# PLAY IT SAFE HOME INSPECTION, LLC

## HOME INSPECTION REPORT

For The Property Located At  
**1334 Anwhere Street, Las Vegas, NV 89148**

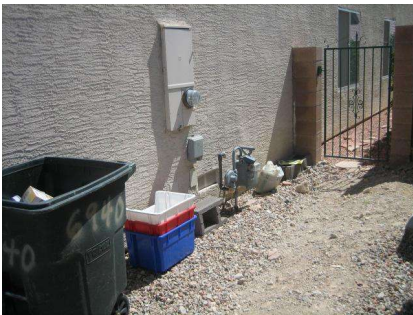
1.1 - PREVENTIVE: The soil is not sufficiently sloped or graded to drain runoff water away from the the south side of the residence. Inadequate drainage and grading around a building can lead to moisture intrusion and create an environment conducive to the growth of mold. It can also damage the foundation and/or cause excessive settlement. As a preventive measure we recommend that the soil be sloped to drain surface water away from the residence for ten feet or more and/or that hardscaping be installed, and/or that an appropriate drainage system be provided.

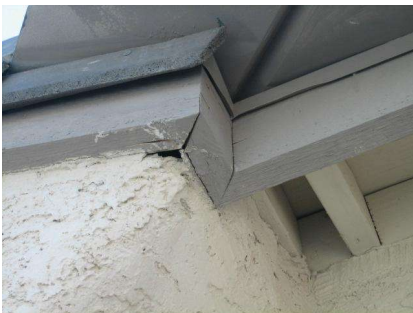
1.4 - DEFICIENT: There are gaps or openings in the stucco wall coverings at the south side of the residence that will need to be repaired or otherwise made watertight in order to help prevent against moisture or pest intrusion.

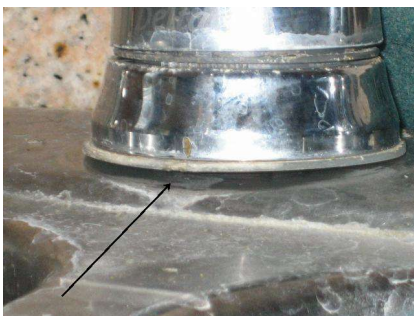
6.7 - DEFICIENT: The faucet at the kitchen sink is loose and needs service.

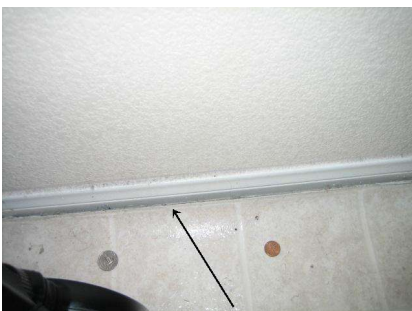
10.2 - DEFICIENT: The vinyl floor coverings in the laundry room have lifted and will need service.

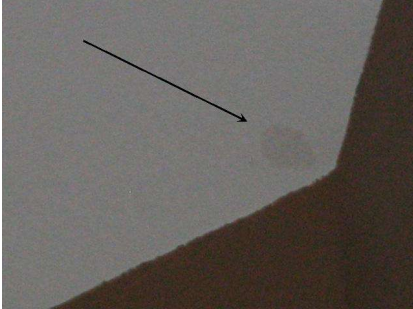
10.4 - DEFERRED: There is a small discoloration in the living room ceiling covering that you will need to have evaluated. This could be just a spot that never got painted properly. You might consider getting this evaluated.
